## Statement of Qualifications for the **CITY-COUNTY OF BUTTE-SILVER BOW**

Basin Creek Dam #1 Rehabilitation

#### RE: Request for Qualifications - Basin Creek Dam #1 Rehabilitation Project

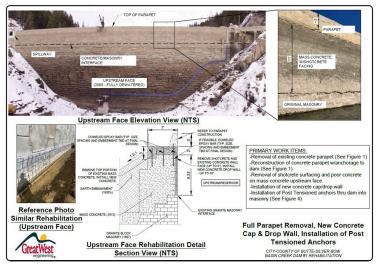
Selected Rehabilitation Alternative (Full Parapet Removal, New Concrete Cap/Drop Wall And Post-tensioned Anchors)

In 2020, BSB commissioned Great West to prepare a Preliminary Engineering Report (PER) and applications for MCEP and RRGL funding. The PER identified the preferred alternative for rehabilitating the structure that included the full removal and replacement of the dam's parapet wall, concrete overlay over the dam face and installation of post-tensioned anchors.

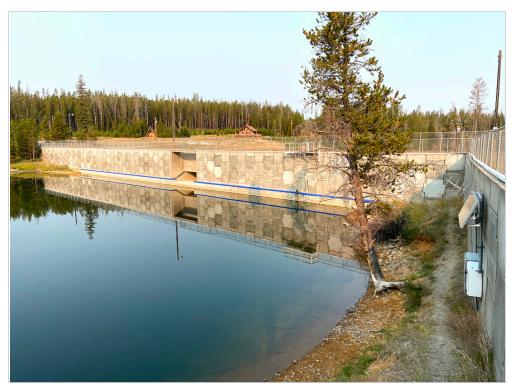
▲ Completed Dam Face Rehabilitation, Upstream Face of Dam

The original masonry core of the Flint Creek Dam was constructed in the early 1900s. Over the years, weather and freeze-thaw action from the reservoir caused significant deterioration of the dam face and upstream spillway slab. Great West aided the County in securing an RRGL grant to partially fund the project. The repair design included a structural concrete cap over the existing concrete and a complete structural replacement of the upstream spillway slab. The project included structural analysis of the anchoring system to ensure the face concrete would survive freeze thaw effects and wave action from the lake. Great West also had to work with the selected contractor to develop a workable dewatering system to install the improvements.

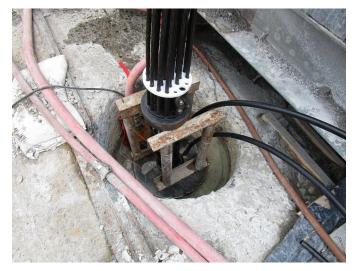
A Post-tensioned Anchor Installation

The purpose of the post-tensioned anchors (PTA) is to stabilize the upper mass concrete against sliding and overturning during the PMF event. This will be accomplished by anchoring the upper mass concrete to the original masonry dam. To ensure that the PTAs are economically feasible, the team will design the posttensioned anchors by optimizing the anchor spacing, orientation, and length. The PTAs will be designed in accordance with Recommendations for Prestressed Rock and Soil Anchor published by the Post-Tensioning Institute and USACE Guidelines. Constructability concerns will be considered throughout design process.

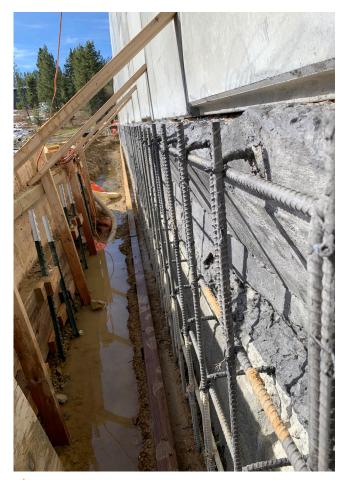
🔺 Reinforcing Along Concrete Dam Face

It is the team's understanding that the concrete overlay will extend from the upstream face, along the crest, and down the downstream face of the mass concrete. The intent of the overlay is to protect and prevent additional deterioration of the mass concrete portion of the dam, thereby extending the life of Basin Creek Dam #1. For the concrete overlay portion of the project, the team will evaluate the concrete mix design and the size and spacing of reinforcement to current American Concrete Institute standards. Additionally, the team will determine the necessary anchorage required to support the overlay of the existing dam. The team will design water stops to prevent seepage through the overlay to the mass concrete preventing both uplift and additional freeze-thaw damage. In addition, the upstream concrete overlay will extend above the crest elevation, replacing the existing parapet and will be designed to withstand the loading from the probable maximum flood (PMF).
